DEVELOPMENT OF FUSED SLURRY SILICIDE COATINGS FOR THE ELEVATED-TEMPERATURE OXIDATION PROTECTION OF COLUMBIUM AND TANTALUM ALLOYS

**S. Priceman
L. Sama
Sylvania Electric Products Inc.
Hicksville, New York**

**Technical Report AFML-TR-68-210
December 1968**

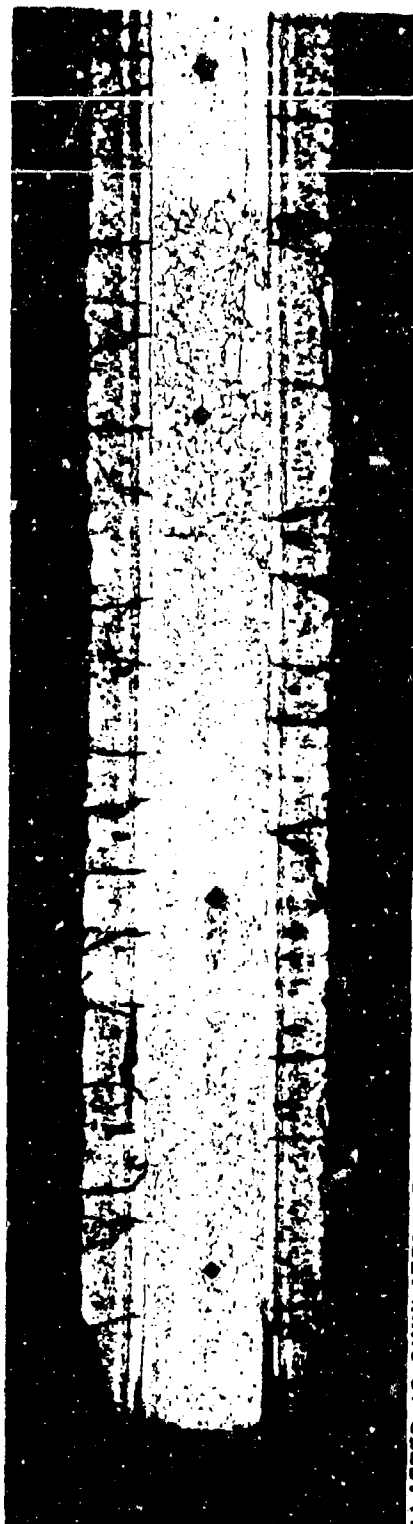
(a) AS DEFECTED (edge of 0.032 hole is at left)

(b) AFTER 10 SIMULATED REENTRY CYCLES

Figure 53 Sections Through Reentry Simulation Exposed Defected Coated Specimens (100X).
(Reduced 10 Percent in Reproduction)

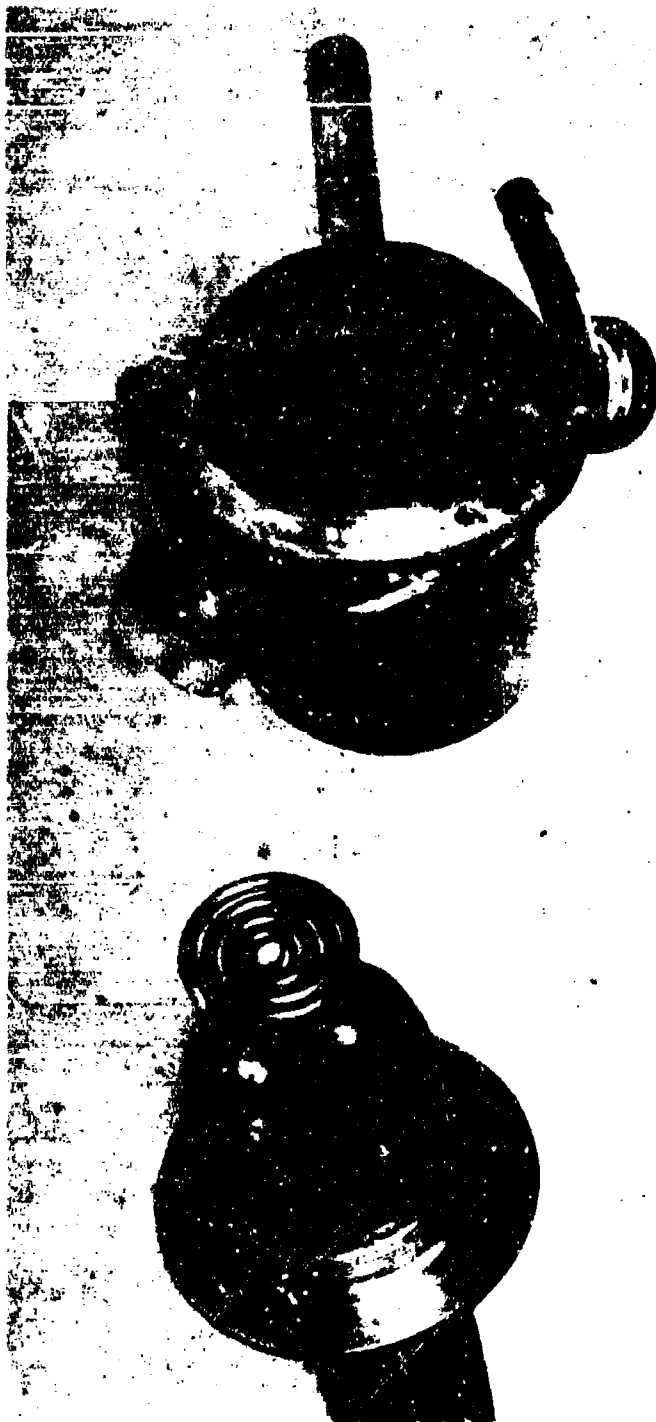
Figure 94 Disassembled View of Coating Repair Unit

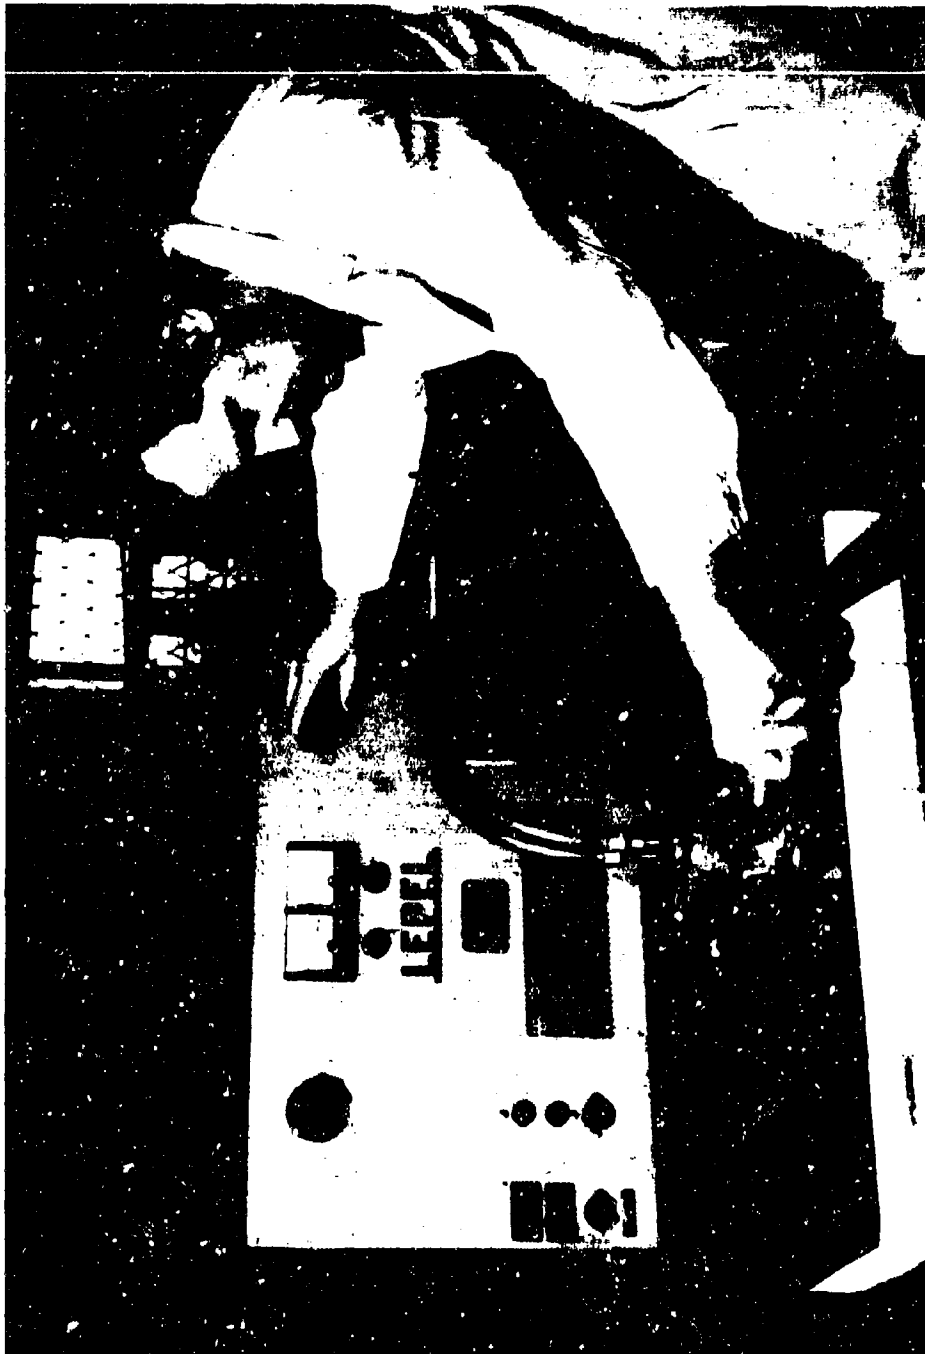
Figure 95 Portable Coating Repair Unit
